AN ASSESSMENT OF THE PERFORMANCE AND RELIABILITY OF OLDER ERW PIPELINES

**R. J. Fields
E. N. Pugh
D. T. Read
J. H. Smith**

**U.S. DEPARTMENT OF COMMERCE
National Institute of Standards
and Technology
Institute for Materials Science
and Engineering
Gaithersburg, MD 20899**

Issued July 1989

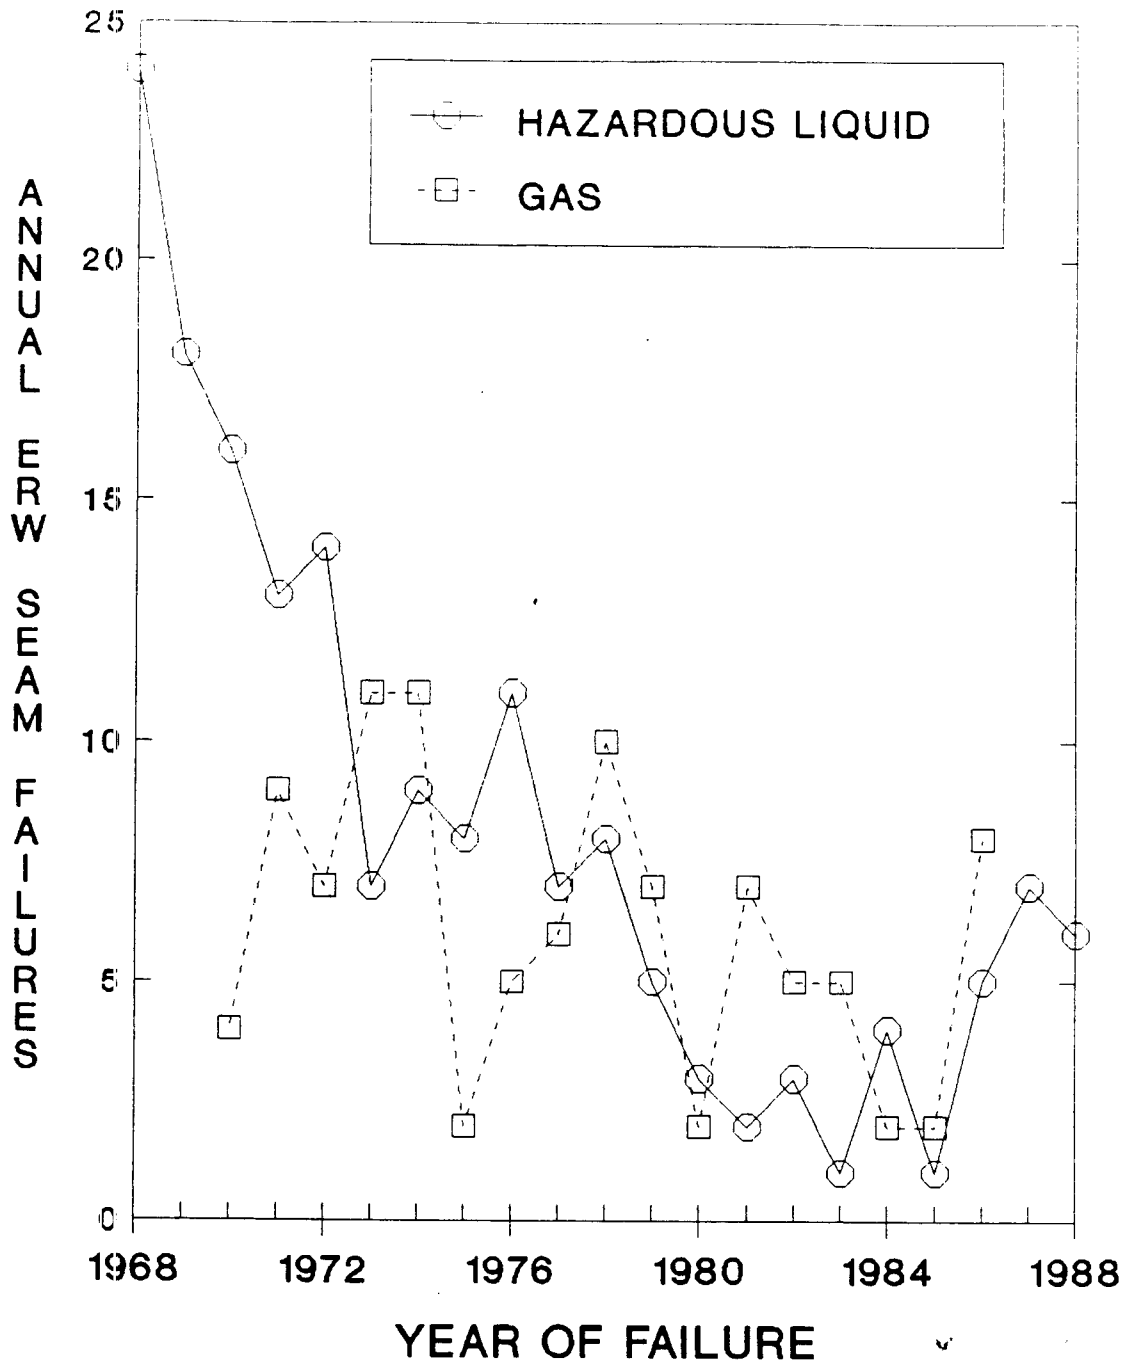
Figure 1. Annual Number of ERW Seam Failures in Hazardous Liquid Transmission Lines and Natural Gas Gathering and Transmission Lines During the Period 1968-1988 (15).

Given the occurrence of corrosion and fatigue, it might be expected that the number of failures per year would increase with the increasing age of the pipe. It is somewhat surprising therefore that no such significant effect is observed in Tables 4 and 5. This can be seen by examining each construction decade separately and noting the number of failures in each event year. Note that while the number of miles of pipe installed per decade is not known it is reasonable to assume that the mileage remains substantially unchanged after the end of a particular decade (neglecting replacement), at least for pipelines constructed after 1950. On this basis, the data suggest that the rate of failure does not increase significantly with time.

The data do not allow strict statistical analysis, but the values for HL, Table 4, indicate that the total number of failures per year was initially large and then decreased to an approximately constant value of about 5 failures per year. This trend is shown graphically in Figure 1. This effect is not evident for NG, Table 5 and Figure 1, where the total number of failures per year fluctuates about an average value of about 6 failures per year. The reason for the initially decreasing trend for HL pipelines over the period 1968 to 1978 is not known.

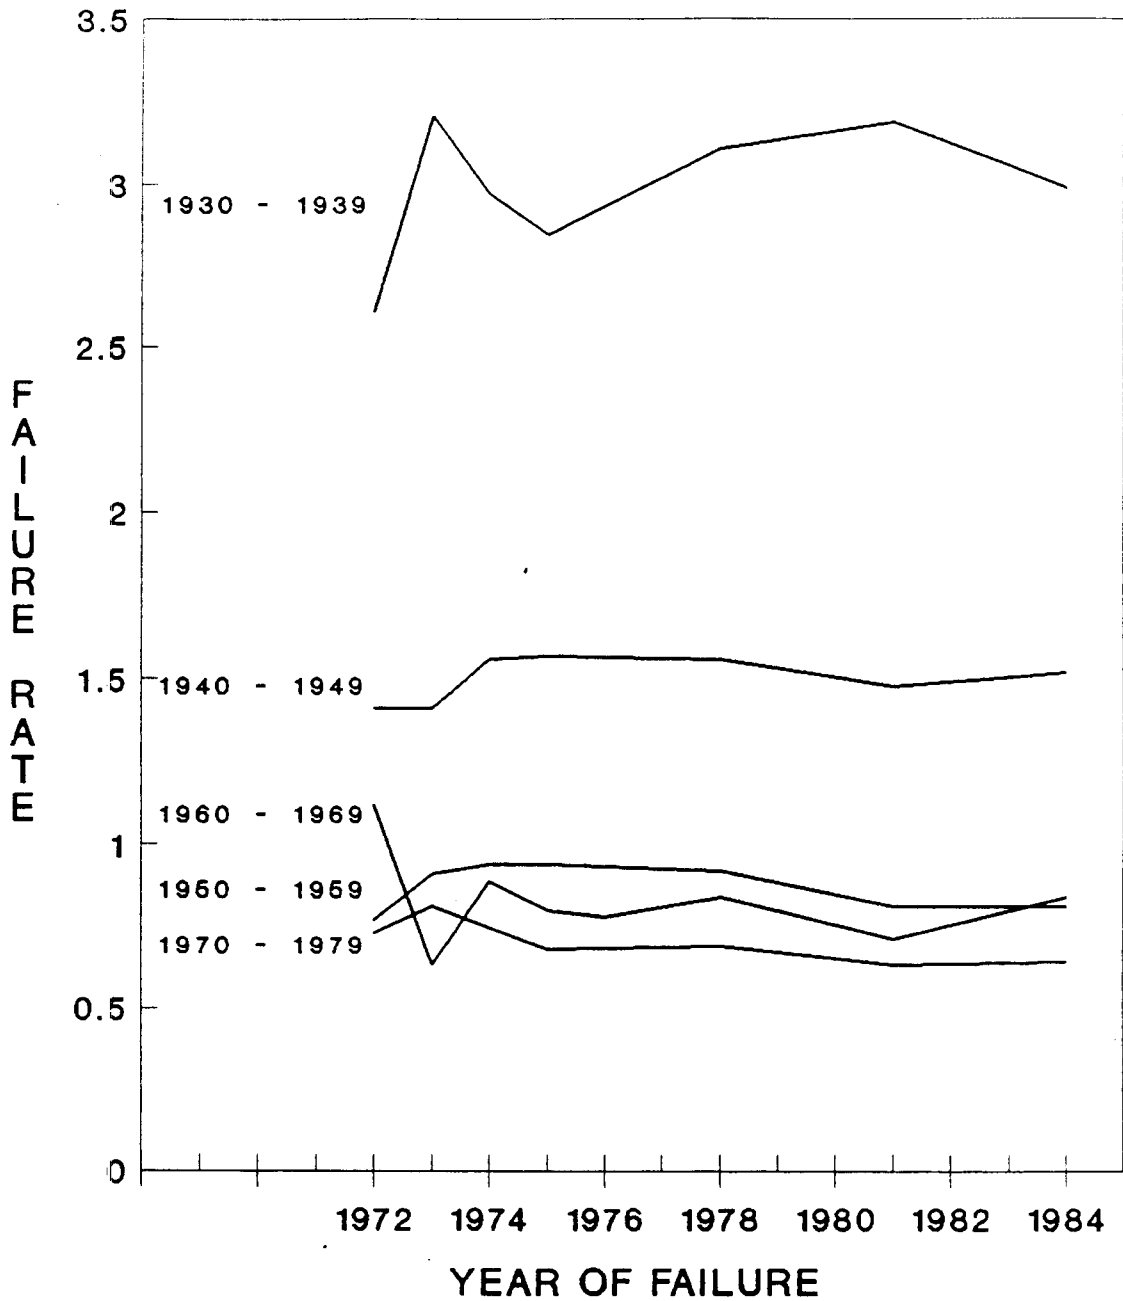
Figure 2. Annual Rates of Failure (number per year per 1000 miles of pipeline) in Natural Gas Gathering and Transmission Pipelines for the Period 1970-1984 Classified by Decade of Construction (16).

The Battelle report on NG pipelines (16) used mileage data similar to those of Table 3 to determine failure rate as a function of construction decade and incident year. Their findings, summarized graphically in Figure 2, show two important points:

- (1) Pipelines constructed in the 1930s and 1940s have significantly higher failure rates than those installed in the 1950s, 1960s and 1970s, the latter showing little differences. The fact that these older pipes show larger failure rates is worthy of attention, but is offset by the relatively small mileage installed in these decades, Table 3, and by the fact that many are being replaced (19).
- (2) As in the case of ERW seam failures, Section 4.2.3, it is somewhat surprising that the failure rate in the period 1970-1984 is essentially constant with incident year for each of the five decades represented in Figure 2. There is no evidence for an aging effect in these data.

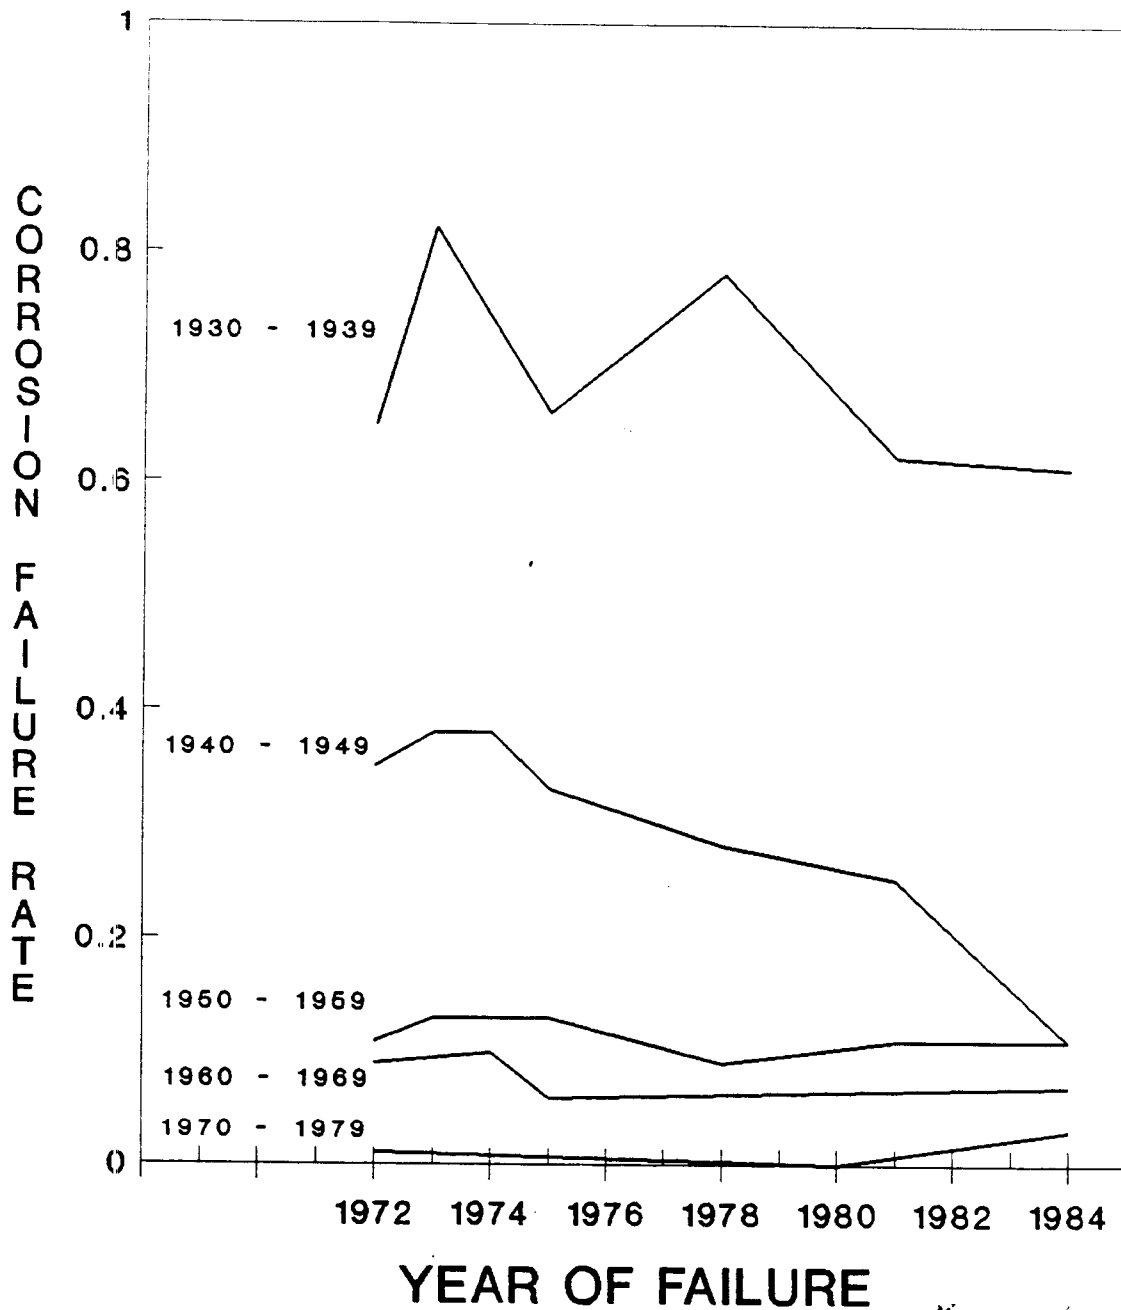
Figure 3. Annual Rates of Corrosion Failures (number per year per 1000 miles of pipeline) in Natural Gas Gathering and Transmission Lines for the Period 1970-1984 Classified by Decade of Construction (16).

Corrosion can be seen to have represented a major cause of failures in NG, Table 7, and HL, Table 8. In addition to the relatively small number of failures resulting from preferential attack at ERW seam welds, it is assumed that these failures stem from wall thinning due to uniform corrosion, and perforation due to localized forms such as pitting, stress corrosion cracking and hydrogen embrittlement (17). However, continued improvements have been made in corrosion protection over the past decade, including the mandatory use of coatings and cathodic protection, and there is evidence in the Battelle study (16) that these measures are having a major beneficial effect. Thus, Figure 3, taken from that report, demonstrates that the rates of failure due to corrosion have decreased markedly over the decades from 1930-1979, and that the rate for the 1970's is very small. Moreover, the failure rate for each decade shows no significant increase with time, again indicating that no aging effects are discernible.

These data suggest that the corrosion problem in pipelines, in general, is being effectively combated. However, it can be seen in Figure 3 that, with the exception of the 1940s, there is no evidence that the failure rate in each decade is decreasing with time. This would suggest that the most current methods of protection and monitoring are not being effectively retrofitted, despite the regulatory requirements (20,21). Thus, as the Transportation Research Board report (18) emphasized, there is a need to sustain and extend our advances in corrosion control. This has particular relevance to older ERW pipe, as indicated in Section 5.0.
